A Historic Structure Report on the William M.
Valentine House

William M. Valentine House
Roslyn, NY

By Florence Westergard

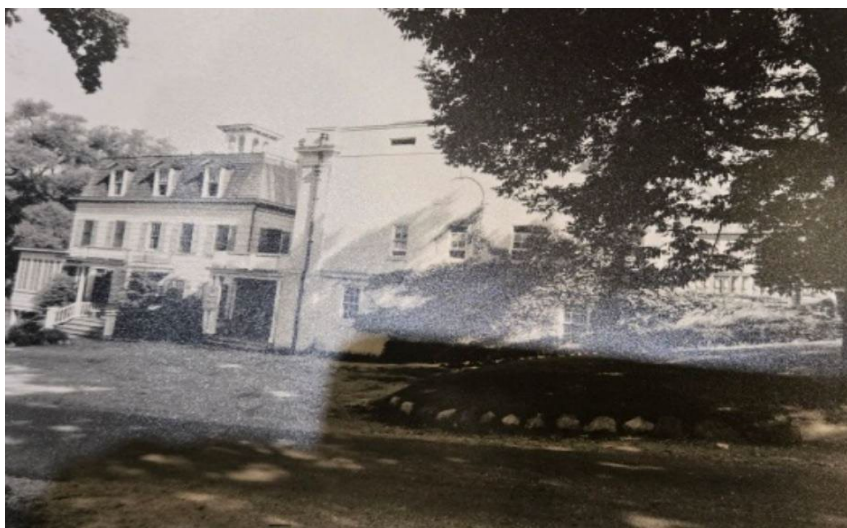
The neighborhood House got attached to the Memorial building through a wing.

The Valentine House is attached to the War Memorial building circa 1920 with a connection wing. Courtesy of the Bryant Library Local History Collection

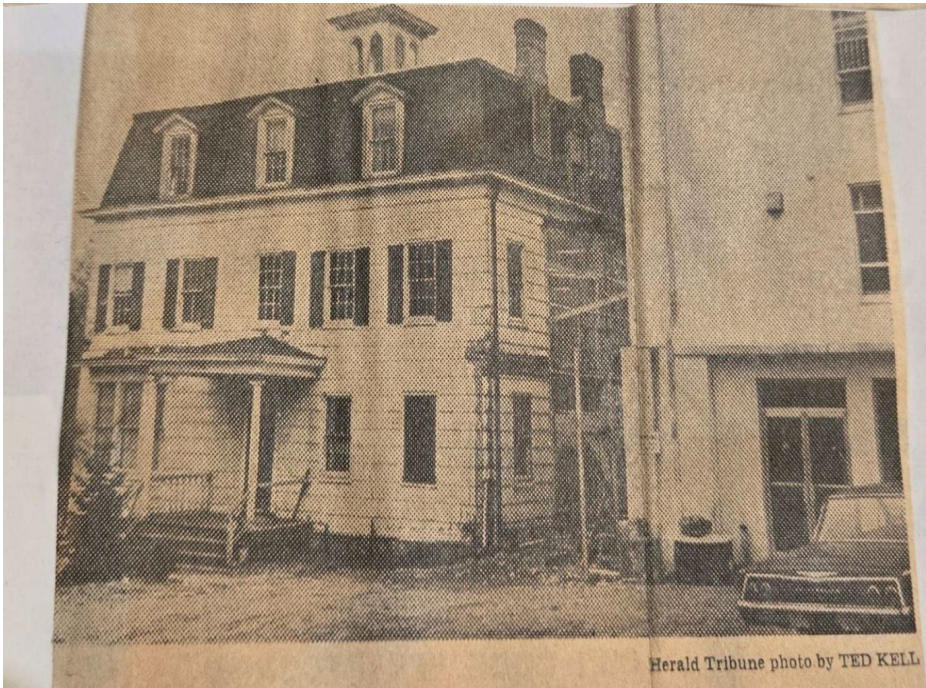
Restoration in 1962 – Source: Bryant Library Local History Collection

Under the supervision of architect Gerald R.W. Watland, the restoration focused on returning the ground floor rooms in the original section of the house to their circa 1800 appearance. All 20th-century modifications were removed, including a later addition—never replaced—along with large, enclosed porches and World War I-era French windows.

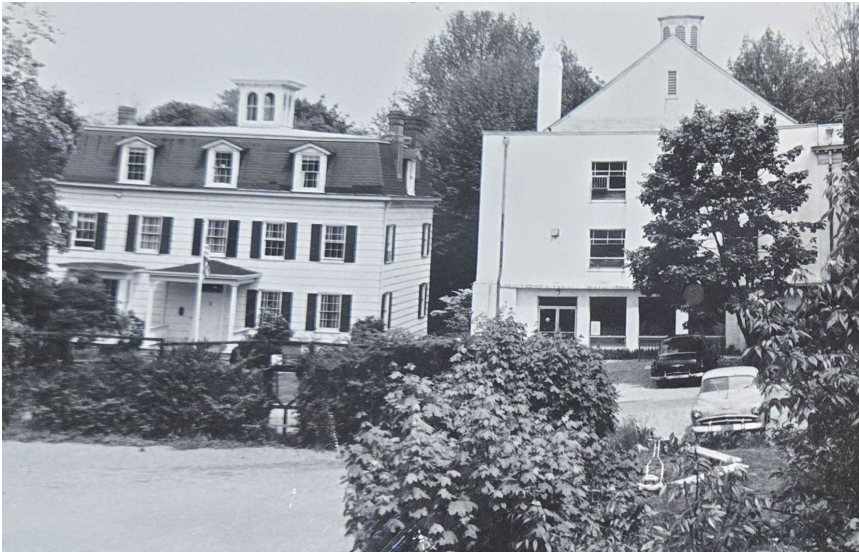
1962-63 - the WM Valentine house restored – Courtesy of the Bryant Library Local History Collection

The original windows were restored, concealed paneling and doors were uncovered and refurbished. Missing architectural elements were identified and reinstalled, ensuring the house retained as many original features as possible.

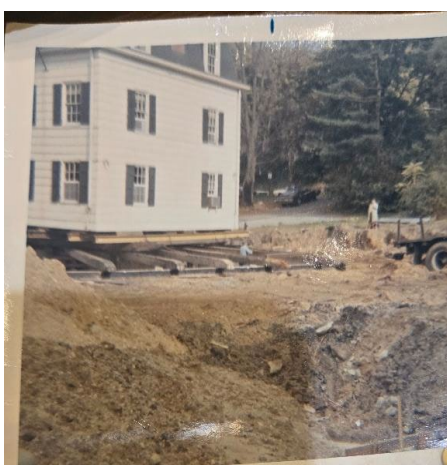
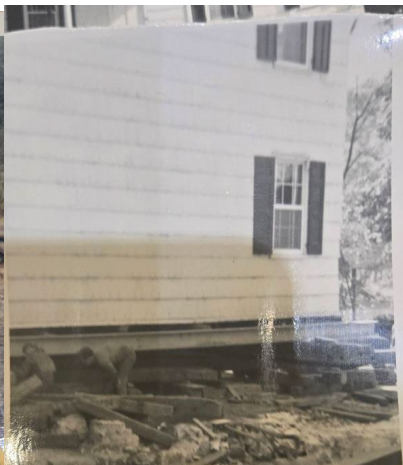
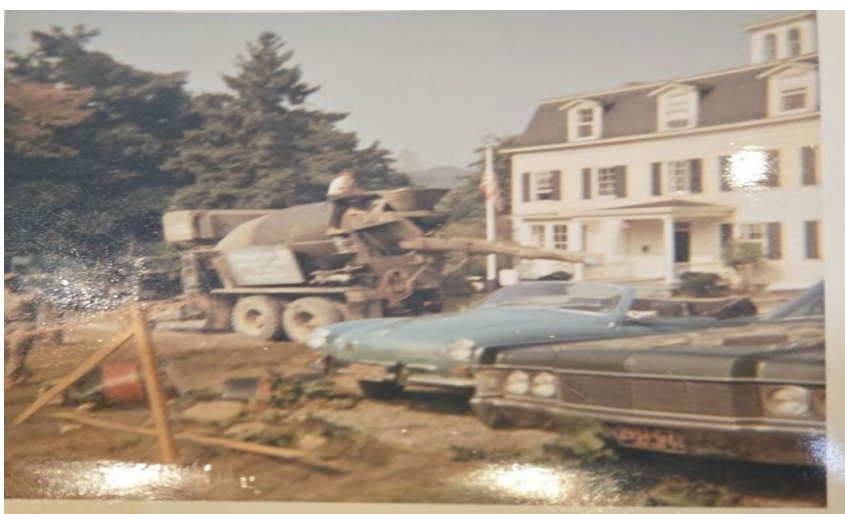
The house was moved to make room for Bryant Library (Memorial Building) expansion. The building was lifted off its original foundation, placed on skids and moved from the west side of the Bryant Library across Paper Mill Road, altering its original site orientation but preserving the building itself.

Various pictures on the William M. Valentine house's move – November 1968
Courtesy of the Bryant Library Local History Collection

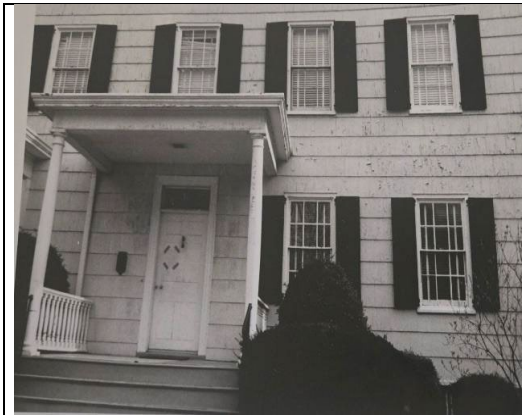
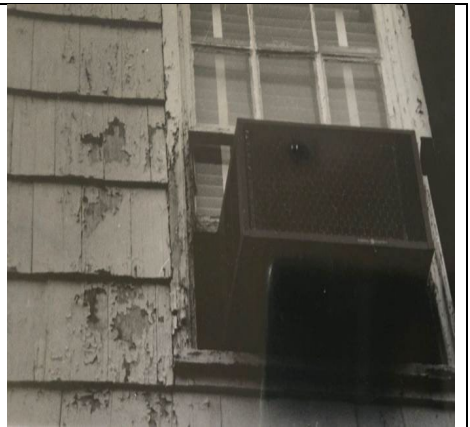
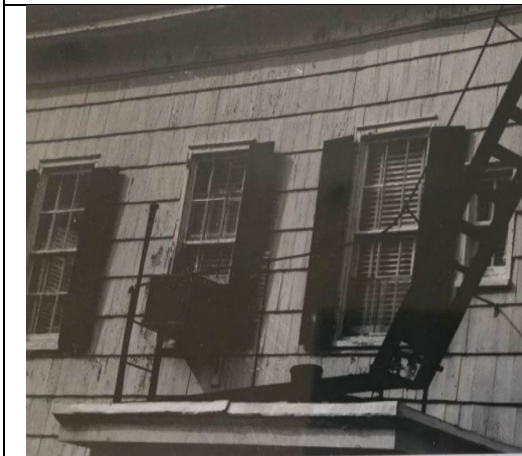
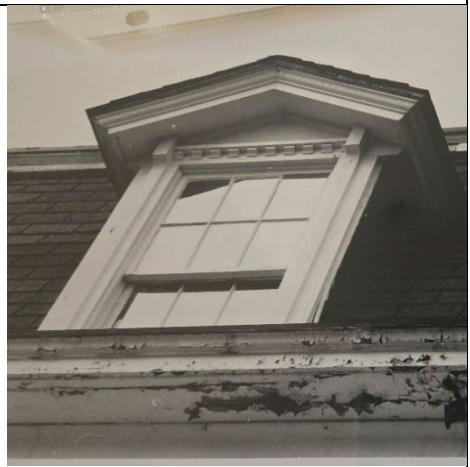
The existing conditions revealed numerous issues, including leaks, damaged ceilings, and outdated electrical systems.

Outside and inside pictures of the William M. Valentine house before renovation in 1995 - Courtesy of the Bryant Library Local History Collection

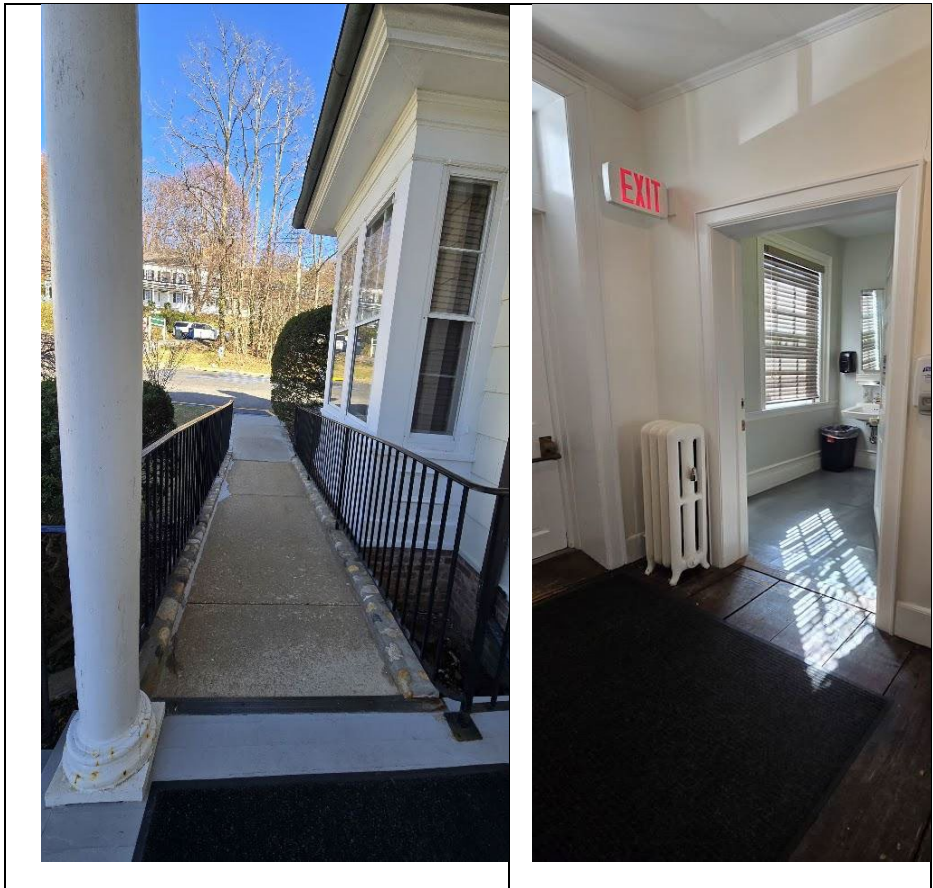
ADA ramp and ADA bathroom on the first floor as they exist in 2025 – Photographs by Florence Westergard

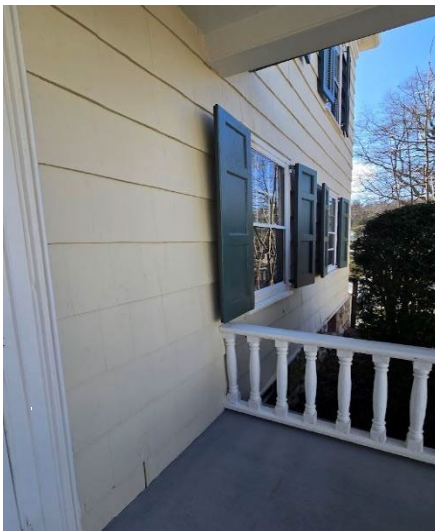
Foundation: Original with modern supports due to the 1968 relocation.

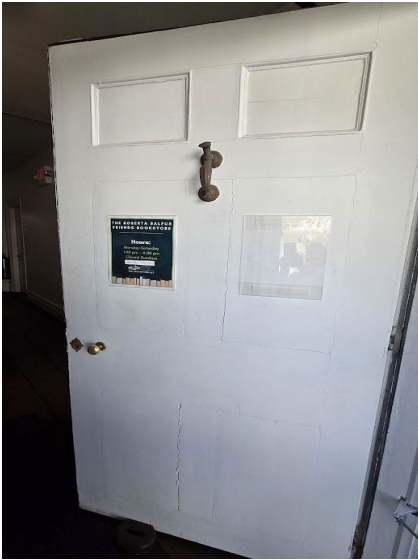
*Front door and Porch of the
WM Valentine House-
Photographs by Florence*

The front doorway is simple but gracefully executed in

Federal detail, utilizing a large six-panel door which has molded edges only on the two small upper panels.

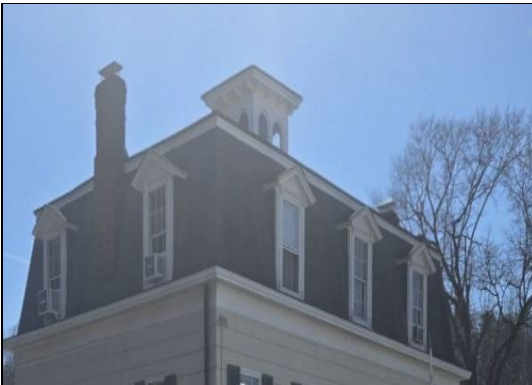
Roof: The slate mansard roof and dormers, added in 1865, reflect the Italianate modifications.

During the 1865 enlargement of the house, the original roof was removed and replaced with a tall mansard roof, typical of the period, allowing for a full-height third story. A glazed belvedere was added to the roof's peak. To accommodate the new roof height, both original chimneys on the east end were extended and finished in the style popular at the time. A matching chimney was added on the west end, which served only the first-floor ballroom/drawing room fireplace.

Structural Maintenance: Perform routine upkeep of the roof and cladding to prevent deterioration and preserve original window frames and flooring to maintain the house's authentic character.

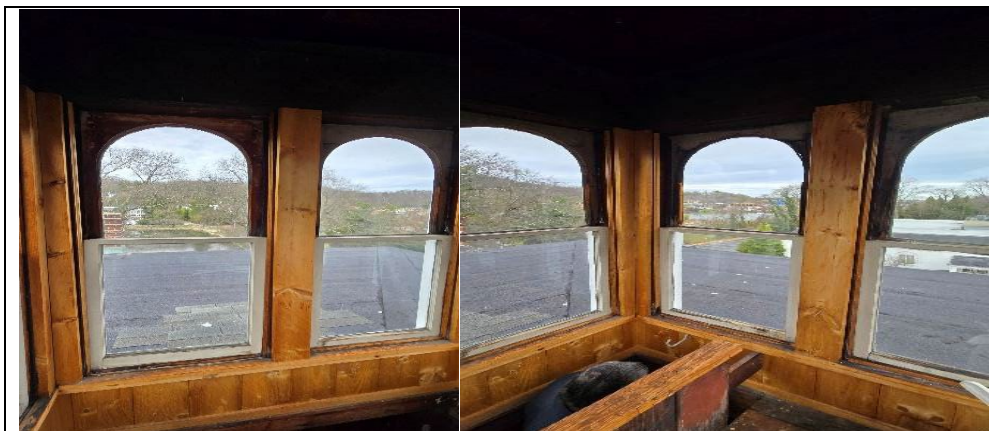
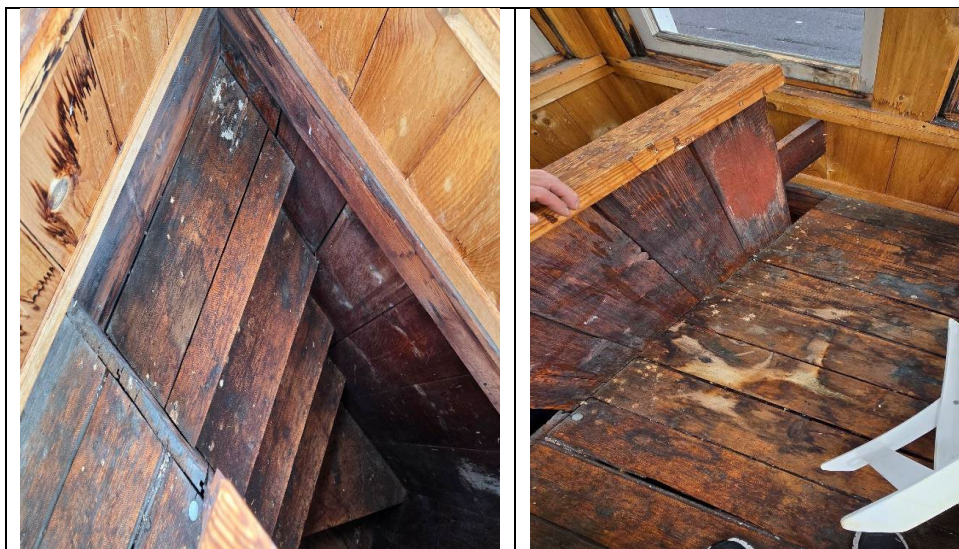
Flooring in the belvedere – Photographs by Florence Westergard

In 2025, it looks like a sound structure with half-round windows. Some are operational. The floor looks original.

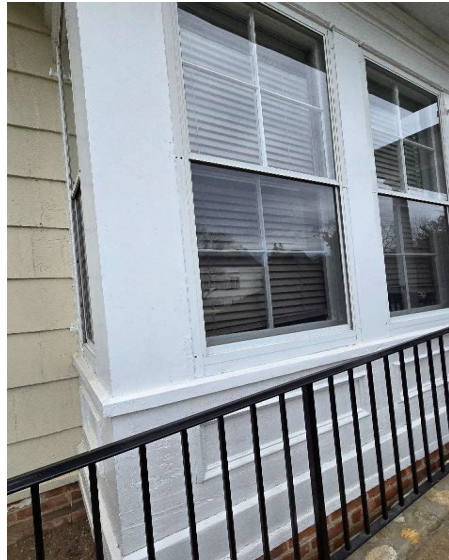
*Bay window west of the door –
Photograph by Florence Westergard*

The structure is depicted in the illustration from the Valentine Family History dating to the early 1870s. However, it features different window framing from the rest of the Civil War-era addition, suggesting it may have been constructed a few years later.

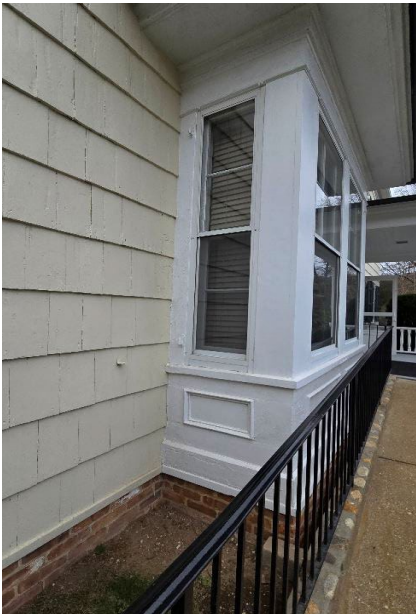
Metal storm windows have since been installed (no date) on the exterior, though the original windows remain intact behind them. Some wood shutters are also missing.

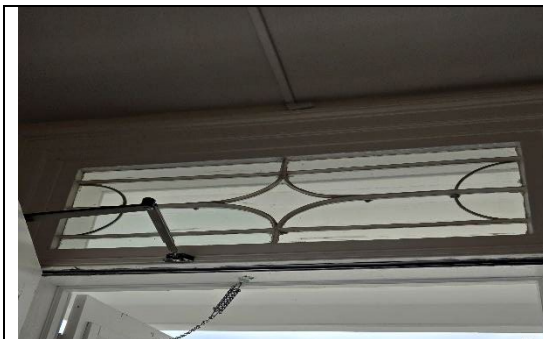
Foyer: Features an original transom window.

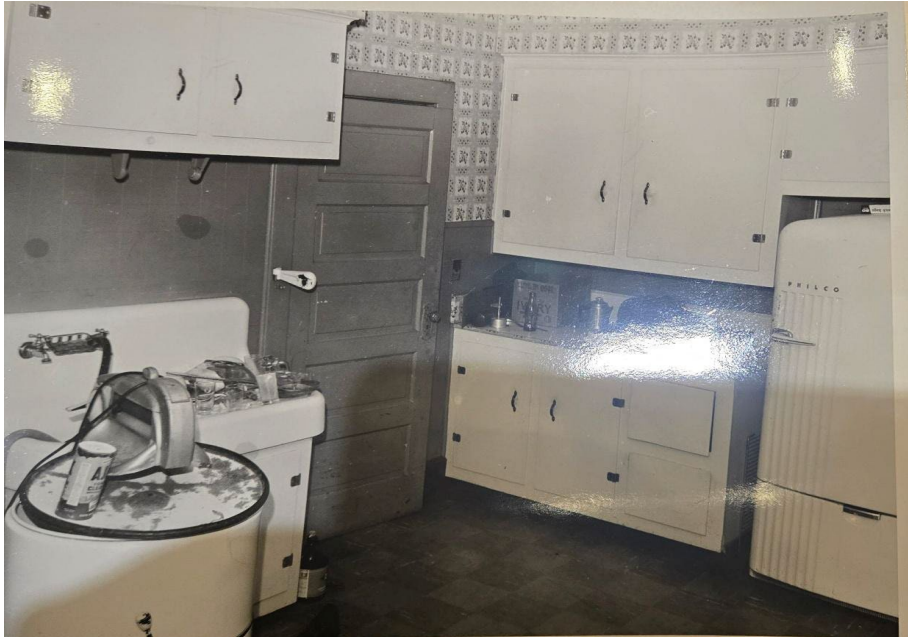
It has been updated during its 1996 adaptive reuse. The kitchen was located on the second floor and was in poor condition.

Undated photo of the kitchen, likely from the 1960s based on the appliances. Courtesy of the Bryant Library Local History Collection.

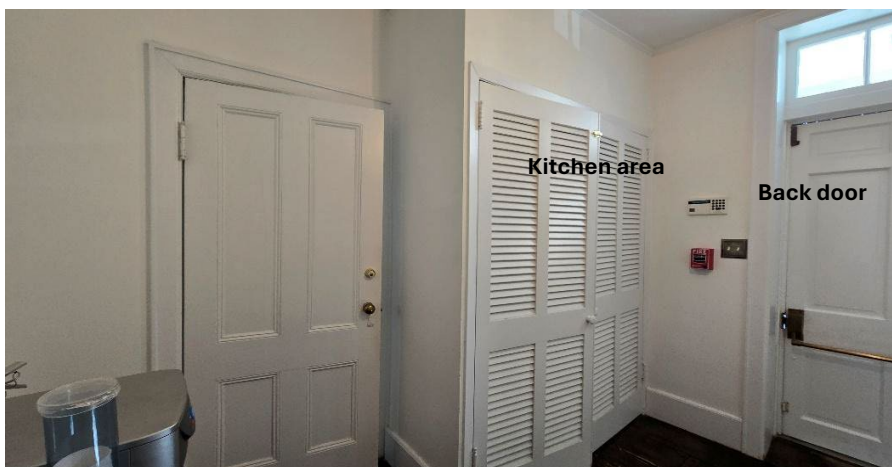
Kitchen area now on the first floor- Photograph by Florence Westergard

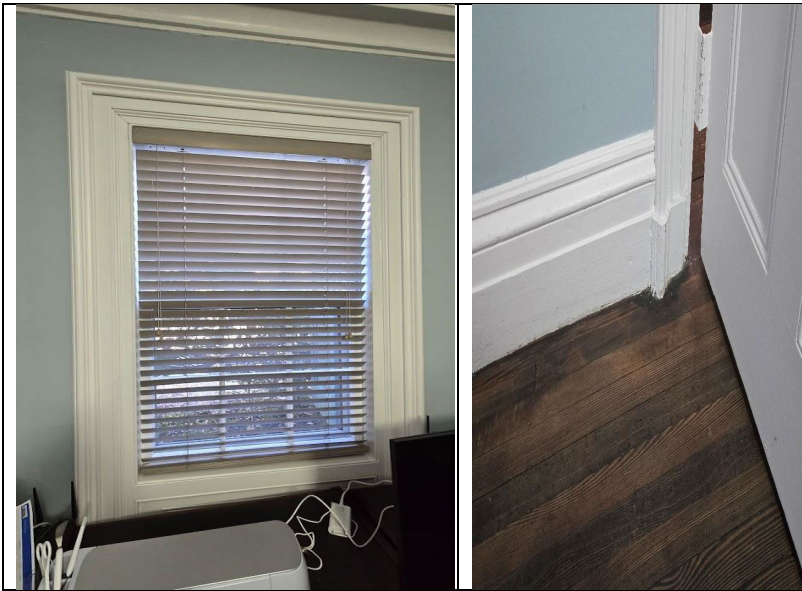
Simple moldings and understated decorative features typical of the federal style. Some of the windows on the first and second floor are paneled beneath the frames, utilizing ogee moldings. As the building is in use, it is difficult to locate all those windows. The base moldings are flat stock wood composite with an ogee top, appropriate for the period of the building.

*Window frame in drawing room Base molding in the drawing room
Photographs by Florence Westergard*

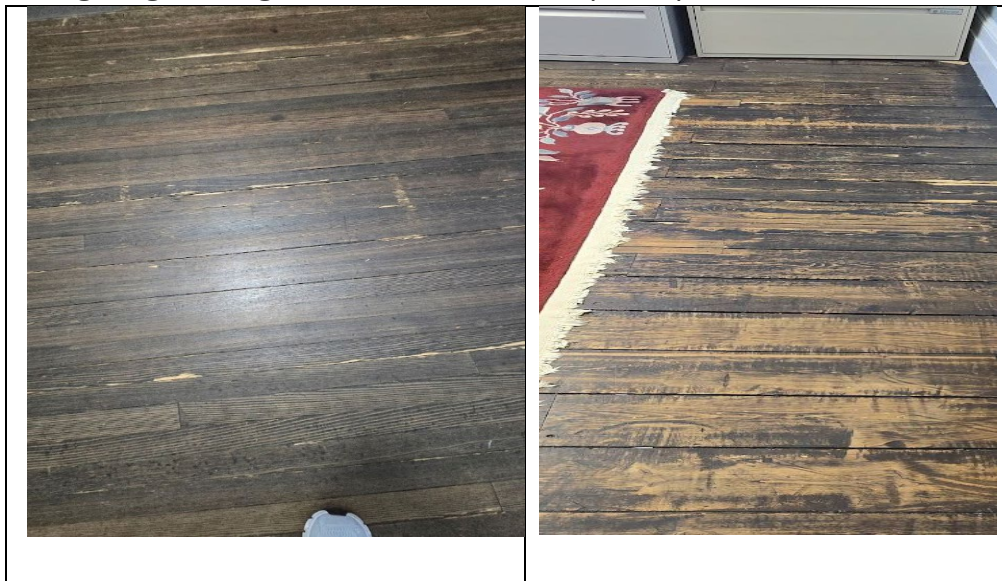
Flooring First floor

The original wide pine floorboards are in place on the first two floors, although those of the first story drawing room (or ballroom) were, until the 1962 restoration, covered with later hardwood floors. The rest of the floor would have been carpeted. They are all exposed now and going through some restoration (2025).

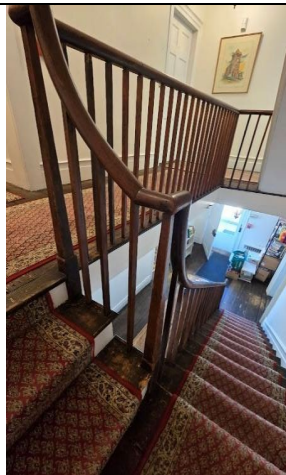
It utilizes a simple square, tapering newel of mahogany with similar secondary newels of cherry. The round stair-rail is also mahogany, but the square balusters are cherry. This use of mahogany and local wild cherry, popularly called "Poor Man's Mahogany" aimed to achieve the maximum in elegance which the builder could afford. The stairs going to the second floor need attention as some areas need to be addressed.

See the secondary newel that extends downward

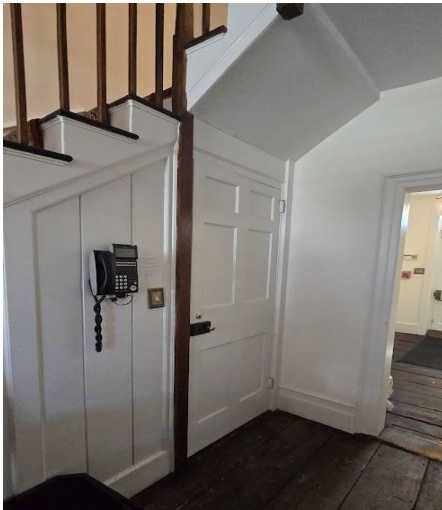
One of the secondary newels extends downward to the floor level to form a part of the cellar door frame. Another extends downward beneath the stair fascia.

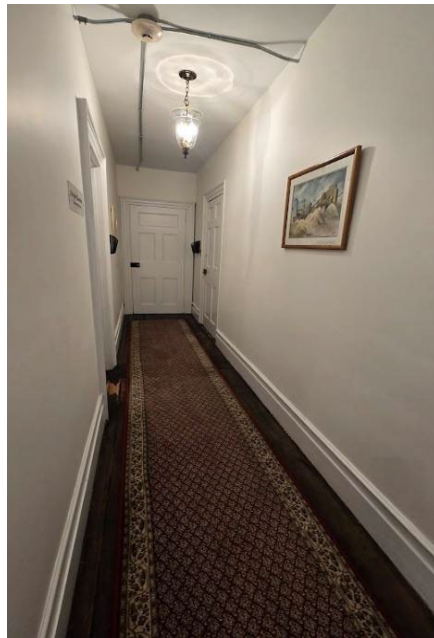
Another interesting feature of the original hallway was the division of the first and second story hallways into front and rear parts. This permitted the utilization of the rear hallways into extra small chambers.

*Second Floor Hallway-Photograph by
Florence Westergard*

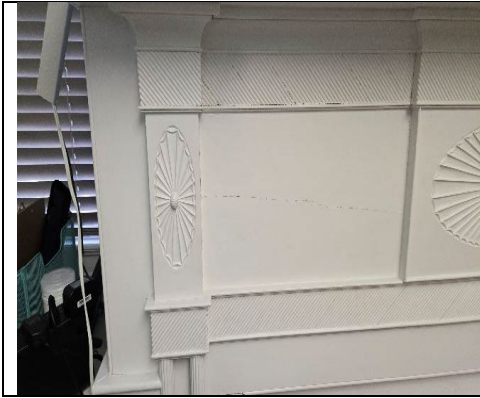
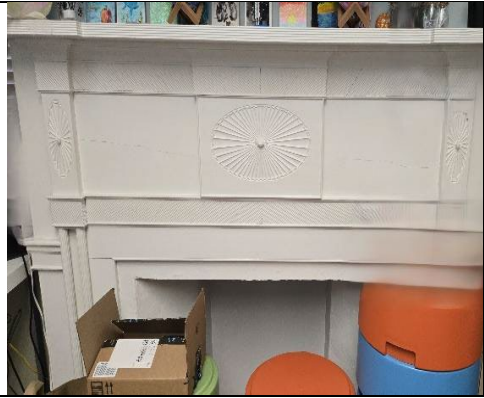
The dining room mantle was accurately restored, utilizing new architectural detail applied to the original backboard. Photographs by Florence Westergard

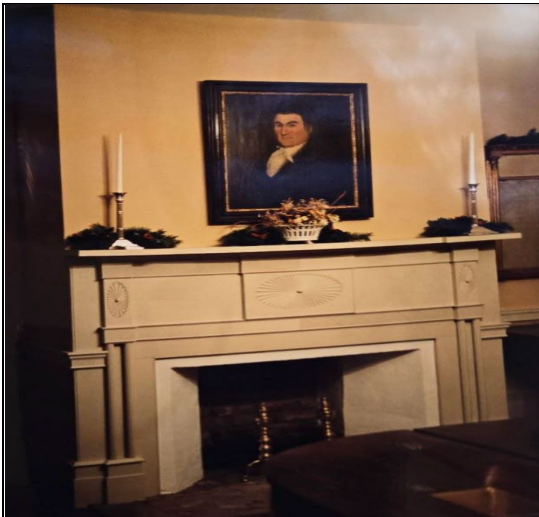
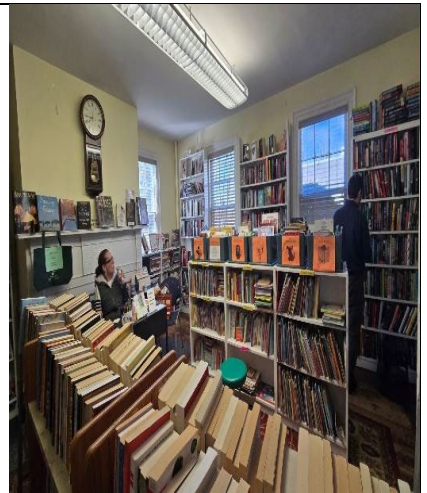
The living room mantle as it appeared in 1987. Now the Library Annex bookstore (photo top right) and details of the fireplace.

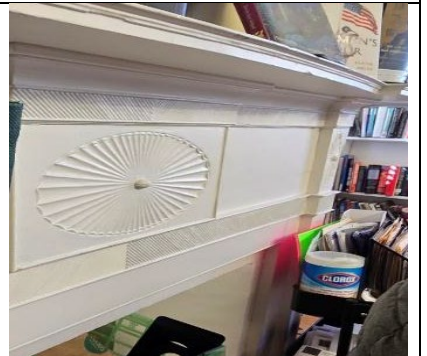
These pairs of mantles are excellent examples of the rural Federal style, and utilize carved sunbursts; shaped, molded mantel shelves; and reeded herring-bone decorative details.

The chair rails and baseboards in both living and dining rooms terminate in the mantle pilasters or colonettes.

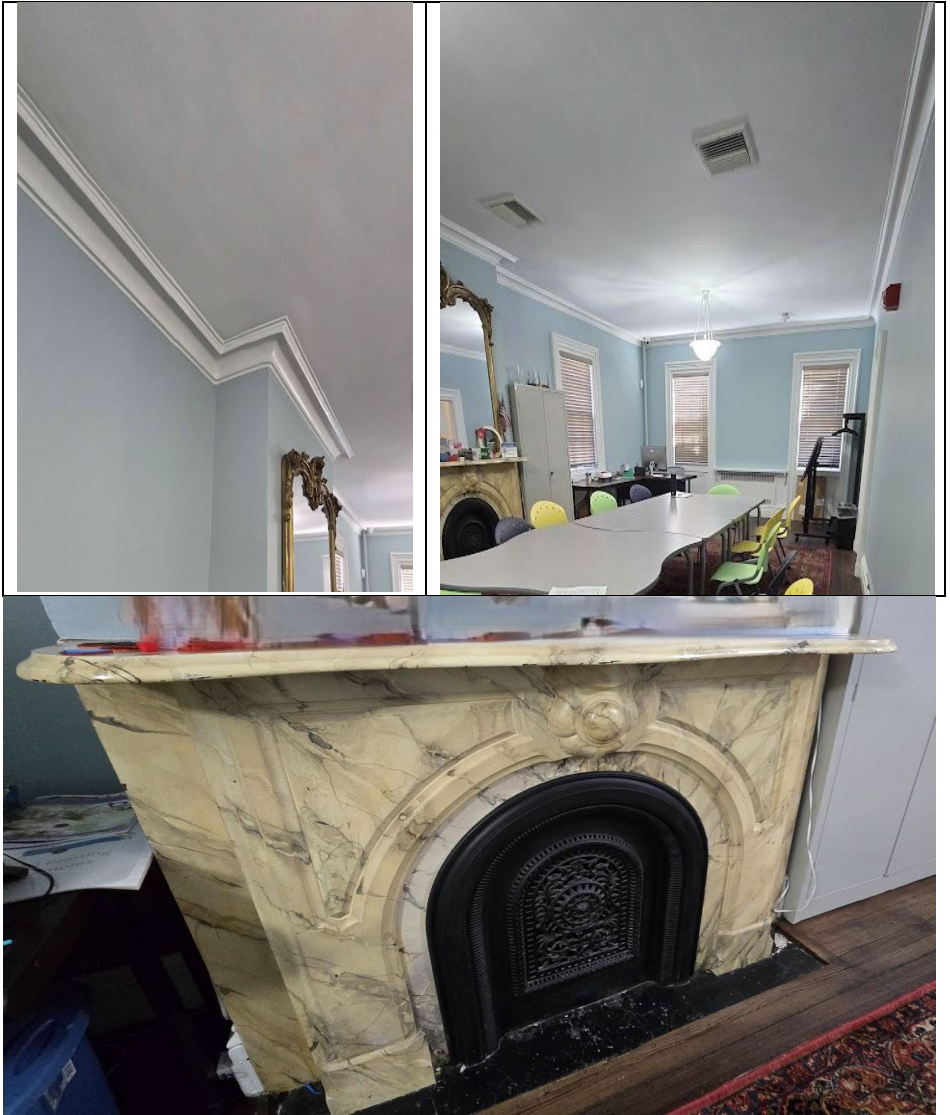
Details observed in the drawing room - Moldings and fireplace
Photographs: Florence Westergard

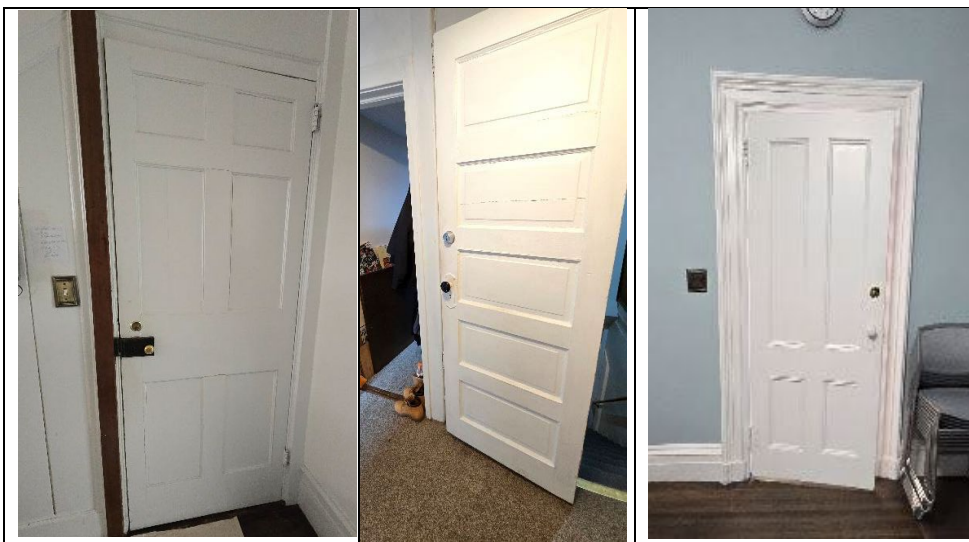
Doors styles throughout the house

Per the [1963 study](#)¹⁰, all the doors were original, except the rear entrance, and two of the interior doors of the second story hallway. But both doors are stylistically from the period with the original doors and are of Nassau County origin. The original doors have four panels, on both sides with ogee moldings.

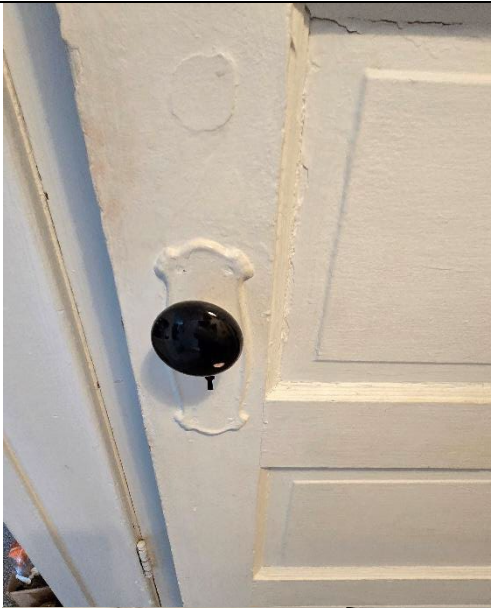
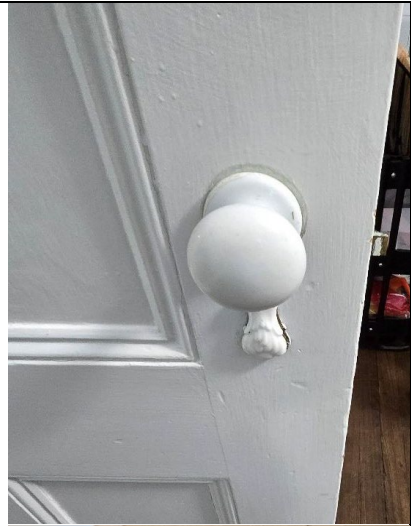
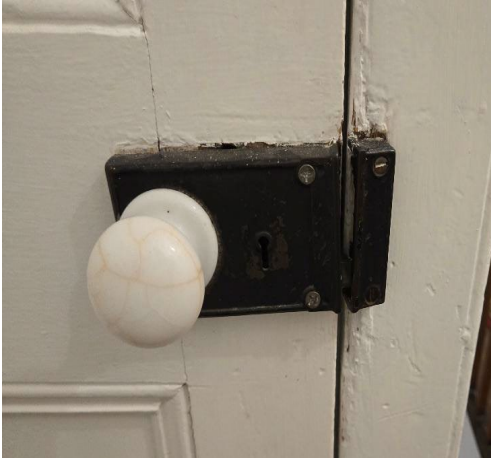
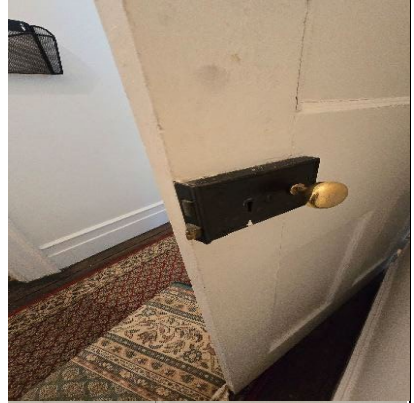
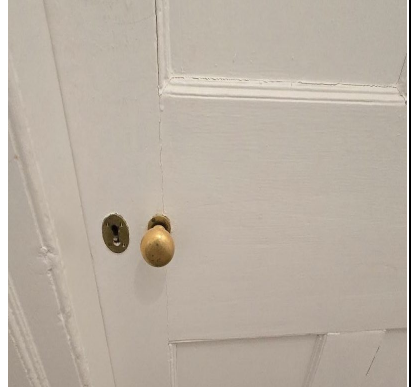
Various locks and doorknobs can be seen throughout the house. The 1963 report states that only one early (but not original) lock survived, that on the dining room door, which was covered with plaster. All the other doorknobs seem to be careful about modern reproductions. In 2025, this cannot be confirmed at this time.

Various locks and knobs throughout the house.

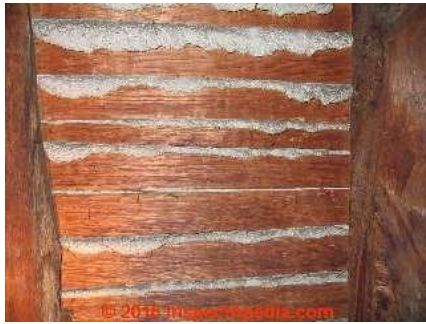
On a structural basis, much of the early clamshell plaster has survived over the original hand split lathing to which it had been applied.

Picture – Example of Hand split lathing
